Location: North Sea
Customer: Major International Oil Company
Well Type: Gas Producer (66 degree deviation)

Case Study Fishing

Recovery of Safety Valve Lockout Tool

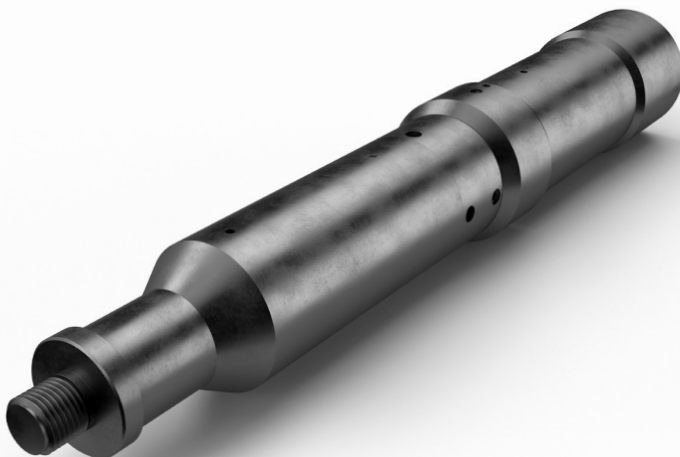
It was identified that the actuation dog of the lockout tool might hinder the retrieval of the housing by sitting across the top of the fish, thus preventing retrieval with a spear.

For one contingency, a gauge cutter was heavily modified to act as a sweeping tool for the actuation dog. In the event that it was needed, the gauge cutter would be rotated around the top of the sub assembly by an indexing tool and would push the actuation dog back into the sub assembly. A High Temperature/High Strength Magnet was supplied for retrieval of the actuation dog and a 2.720-in Releasable Spear for retrieval of the sub assembly.

The High Temperature/High Strength Magnet picked up the actuation dog and the Releasable Overshot speared the inner spring mandrel on the first attempt and pulled the fish to surface.

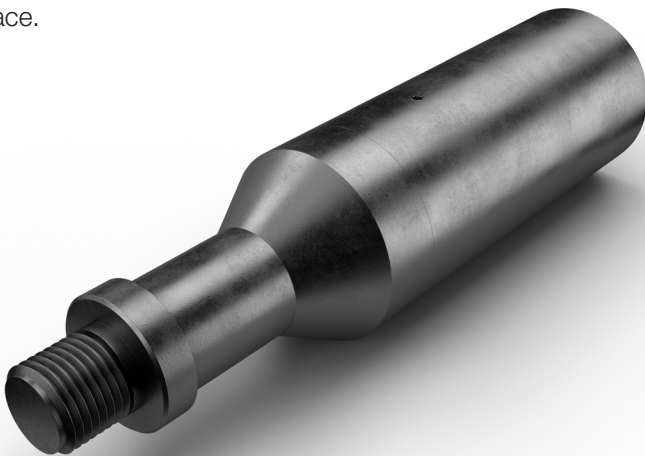
▲ High Temperature / High Strength Magnet

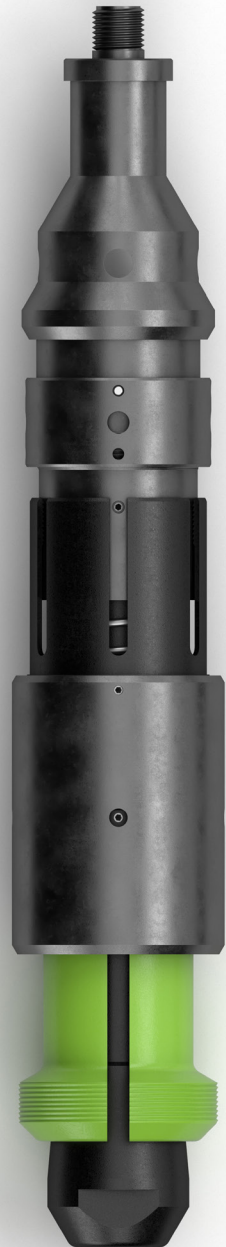
▲ Releasable Spear
