Case Study Fishing

Retrieval of Equipment Lost in the Well and Fast-Track Production Restart

February 2017 | CS-06

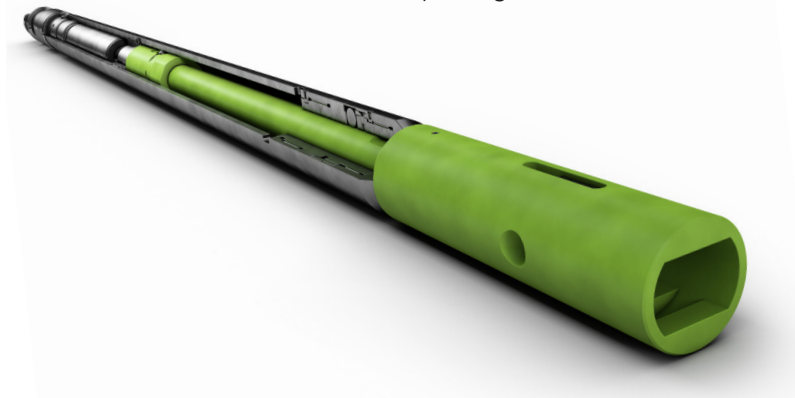
▲ Peak Power Jar

At surface, the Peak Power Jar was set to fire at 1,500lbs. The Power Jar was fired 37 times downhole and the Tractor and Mill Assembly was recovered successfully.

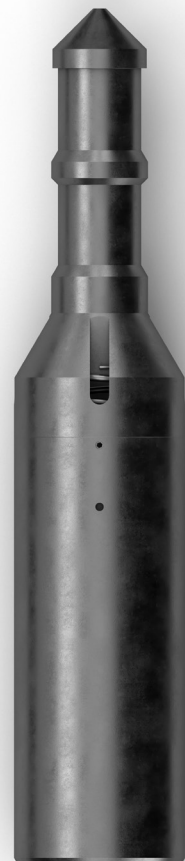
▲ Non-Releasable Overshot

Peak designed, manufactured and tested contingent recovery tools including a 4 ½-in Extended Overshot to fish 4-in OD, also a 3.35-in Non-Releasable Overshot to engage 1.46-in OD, and a 3.15-in Non-Releasable Replacement Rope Socket to engage the 1-in Titan Fish Neck to facilitate heavy jarring.

A UK service company was mobilized to supply the Peak Ultra-Heavy-Duty (UHD) fishing package with a Peak Systems Specialist. Operations commenced and the Peak 3.35-in Non-Releasable Overshot with Dual HD Fish Neck (2.375-in - 2.5-in Slips) was planted onto the fish. The Peak 2.6-in HD FRC Pulling Tool with 3.2-in Integral Bell Guide was then run to engage the Non-Releasable Overshot.
