High deviation fishing at depth in the Middle East

Location: Offshore, Middle East

Products/Services: Rollerised Cutter and High Deviation Toolstring consisting WellGlides, Power Jar, Linear Jar and Accelerators

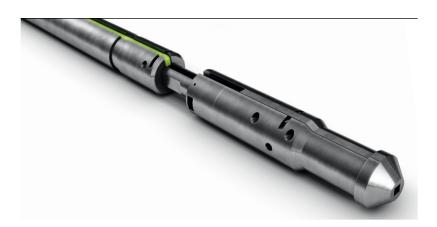
▲ Peak's WellGlide: a fluted roller centraliser sub, designed to assist conveyance of a wireline toolstring into high angle, deviated wells.

WellGlide can be positioned along the length of the toolstring, to lift the body and the weight of the string, upon the axles of the rollers incorporated within the roller subs. This eliminates any friction between the toolstring body and the tubing wall, thus making it perfectly suited to deploying toolstring in highly deviated wells.
