Location: North Sea
Customer: UK-based Operator
Well Type: Water Injector
(max 40 degrees deviation)

Products/Services:
4 ½-in OD Heavy-Duty
Releasable Spear

Case Study Fishing

Retrieval of Injection Valve Backed off From 7-in Retrievable Bridge Plug

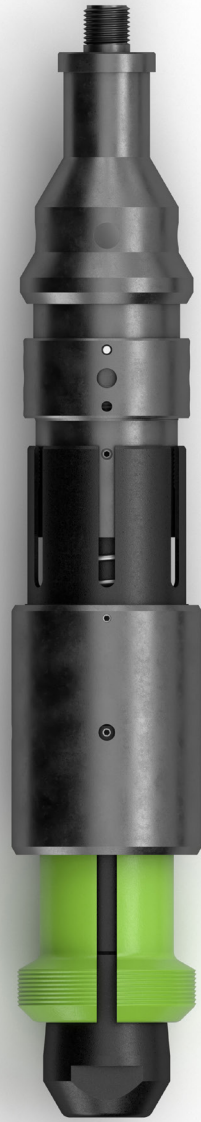
▲ Releasable Spear

During the onshore trial it was established that the crossover could only be located at the smaller ID where it would make contact with the poppet of the injection valve. The injection valve required 125 lbs minimum force to compress the poppet and the full travel to open the injection valve was 5.52 in. With the poppet fully compressed this would allow the Peak Releasable Spear to locate the inner ID on the crossover.

Following rapid mobilization of Peak's 4 1/2-in OD Heavy-Duty Releasable Spear to the offshore platform, it was successfully run in hole to the location of the crossover at 9,901 ft. After the latching process, the pick-up weight increased 100 lbs, confirming the 4 1/2-in OD Heavy-Duty Releasable Spear had a grip of the injection valve.
